# **General Aviation Airworthiness Alerts**

**AC No. 43-16**

**ALERT NO. 219  
OCTOBER 1996**

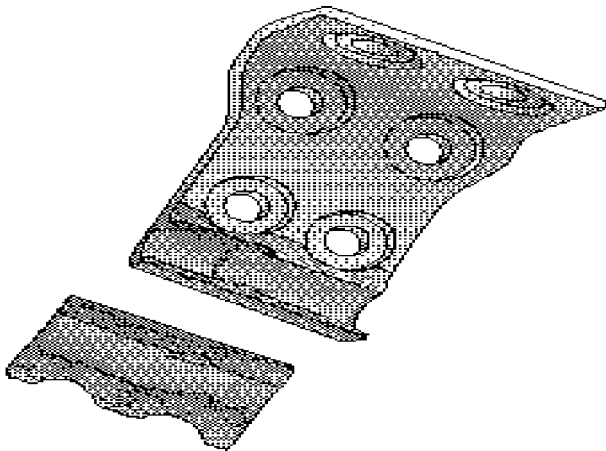
Further inspection disclosed the lower door hinge (P/N 35-400008-12) was causing the problem. After gaining access to the hinge assembly, the steel hinge pin (P/N MS20392-2C63) was found "frozen" in place by severe corrosion. While removing the hinge, it broke at the hinge radius. (Refer to the following illustration.) The submitter stated that inspection and lubrication of this hinge is very difficult without removal of the door. Door failure during flight could cause a catastrophic aircraft accident. The door hinge area deserves close scrutiny during scheduled inspections and maintenance.

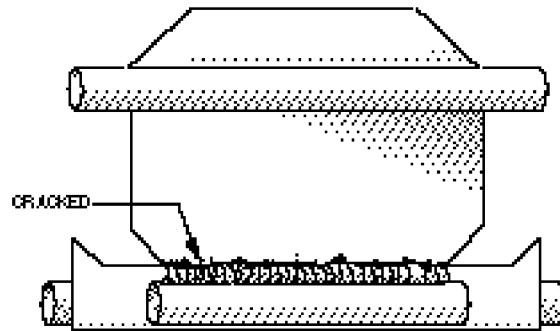
**Nose Landing Gear**  
**Crack**  
**3220**

The paint was flaking off of the steering collar (P/N 19453-30) in an unusual pattern. When all of the paint was removed, the weld on the steering collar was found cracked from one side to the other. (Refer to the following illustration.) The submitter did not offer a cause for this defect.

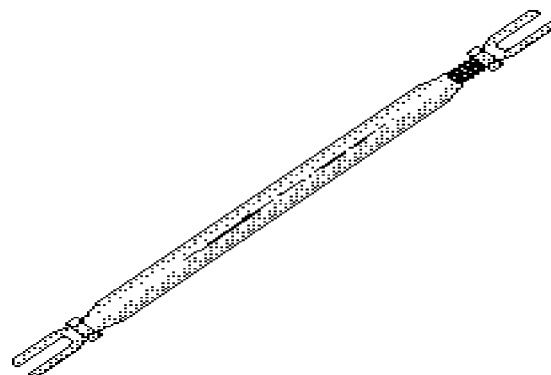
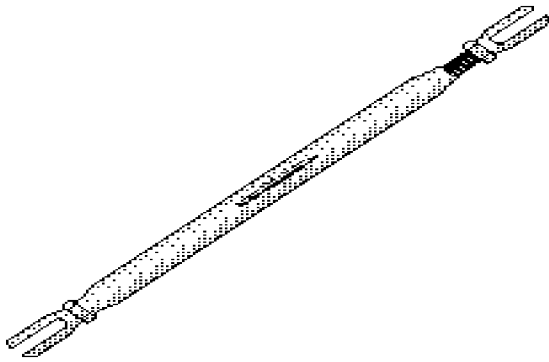
**Cessna                      Rudder And Elevator**  
**Model 500                Trim Control Defects**  
**Citation                    2721 and 2731**

The rudder push-pull tube was split lengthwise approximately 80 percent of its length. The submitter speculated this may have been caused by water trapped inside the tube causing it to split when the water froze.

The elevator push-pull tube was found with a "braze" repair over a split. The "braze" material was also split, exposing the tube split and the tube interior. (Refer to the following illustrations.)

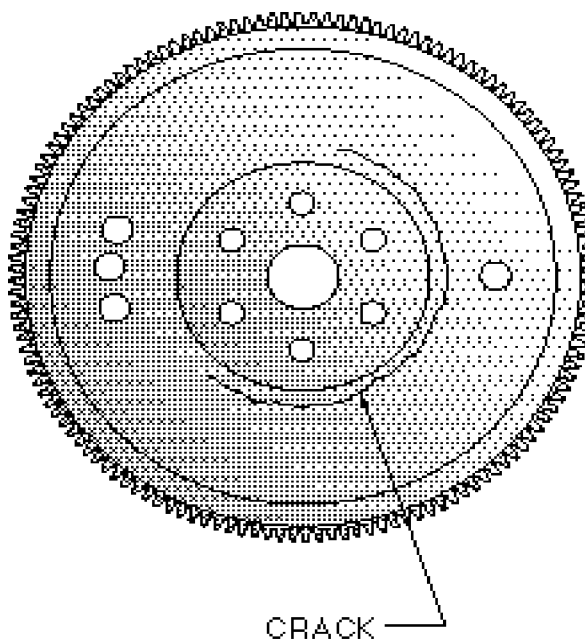
**Piper**                                      **Engine Starter Ring**  
**Model PA 22-135**                      **Crack**  
**Tri-Pacer**                              **8012**

During an annual inspection, a crack was found in the face of the engine starter ring support.

A dye-penetrant inspection revealed the crack traveled approximately half-way around the circumference of the starter ring support (P/N 69340). However, the crack did not penetrate the thickness of the ring gear support. (Refer to the following illustration.) The submitter did not offer a cause for this defect.

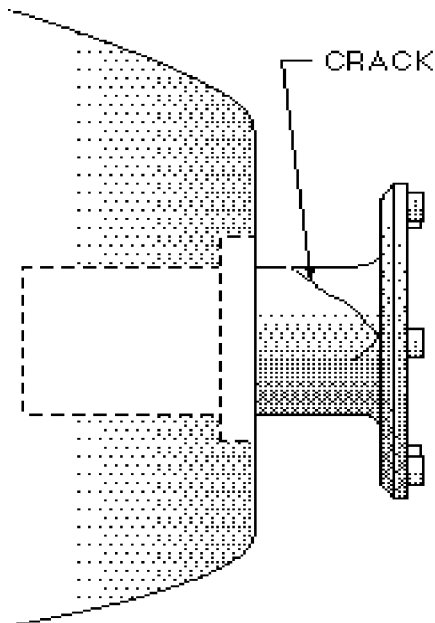
**Crankshaft Crack**  
**8510**

The engine installed in this aircraft was a Textron Lycoming Model O-320-D3G. During an investigation, the engine crankshaft (P/N LW-17060) was found cracked. (Refer to the following illustration.) The crack appeared to have originated at the propeller flange radius. The crack was detectable visually for approximately 1.75 inches. At the time of this report, the cause had not been determined.

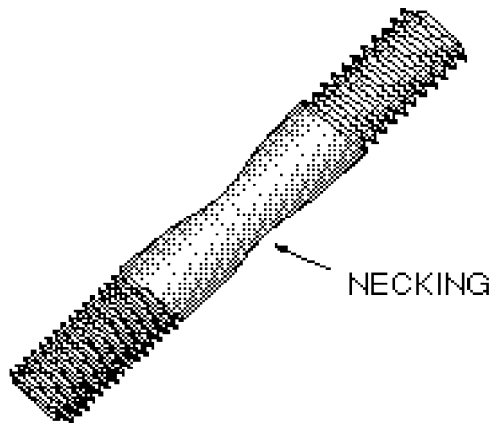
Thirty-six new studs (P/N 643651-1) were ordered (12 from each of three separate vendors) and were received in "TCM" marked packages. While installing these studs and applying the minimum torque, 12 of the studs "stretched." (Refer to the following illustration.) The exact origin of these studs has not yet been determined, and a sample has been sent to Teledyne Continental for metallurgical analysis. At this time, the analysis results are not available; however, as soon as they become available, they will be published in this publication.
